National Transportation Safety Board

Safety Recommendation

In reply refer to: H-01-28

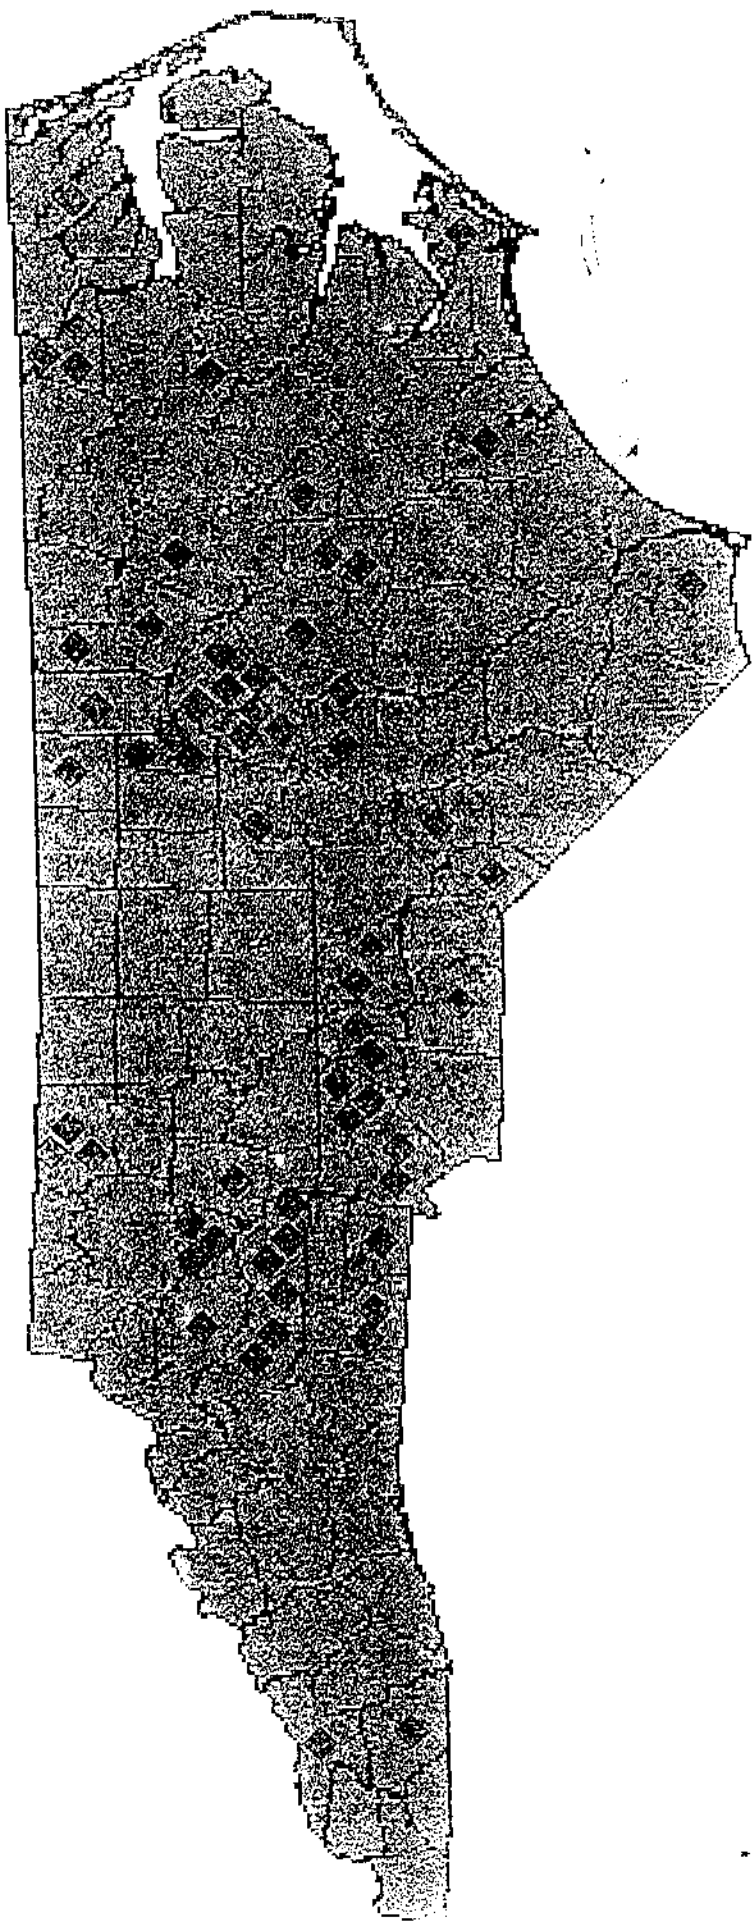
LOCATIONS WITH SEVERE DAMAGE

Although the presence of the guardrail system had little effect on the severity of the accident, Safety Board investigators were concerned that the extensive termite damage found in some of the guardrail posts could have compromised the safety of the smaller private passenger

In summary, based upon our investigation of guardrail installations with wood posts, we recommend that the standard be modified to specify steel guardrail posts with recycled plastic offset blocks. Marie Sutton advises that numerous manufacturers of recycled plastic offset blocks are approved who should be able to meet the demand. The Chief Engineer's Office and the Division Engineers have reviewed this information and are in full support of this recommendation.
